1994 Northridge Earthquake

Performance of Structures, Lifelines and Fire Protection Systems

NISTIR 5396

March 1994
Building and Fire Research Laboratory
National Institute of Standards and Technology
Gaithersburg, MD 20899

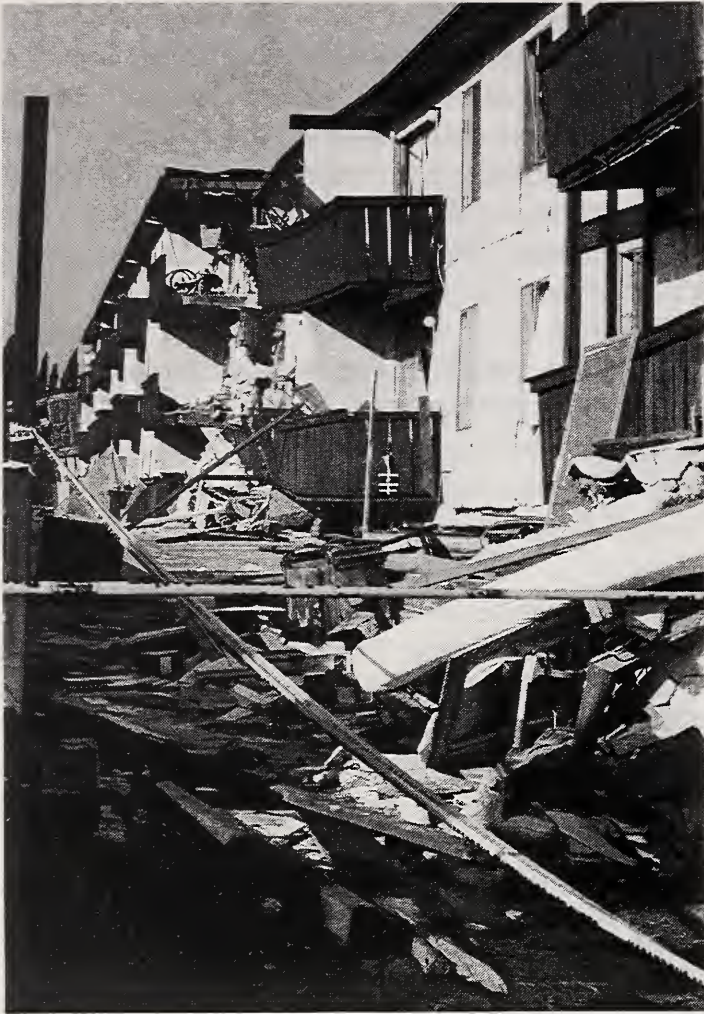
Figure 3.4 At the Northridge Meadows apartment complex near the epicenter the first story in several of the buildings collapsed, killing sixteen people. The second and third stories remained essentially intact. Large portions of the first story in these buildings were open space for parking. This type of collapse occurred in a significant number of similar apartment buildings throughout the affected area.

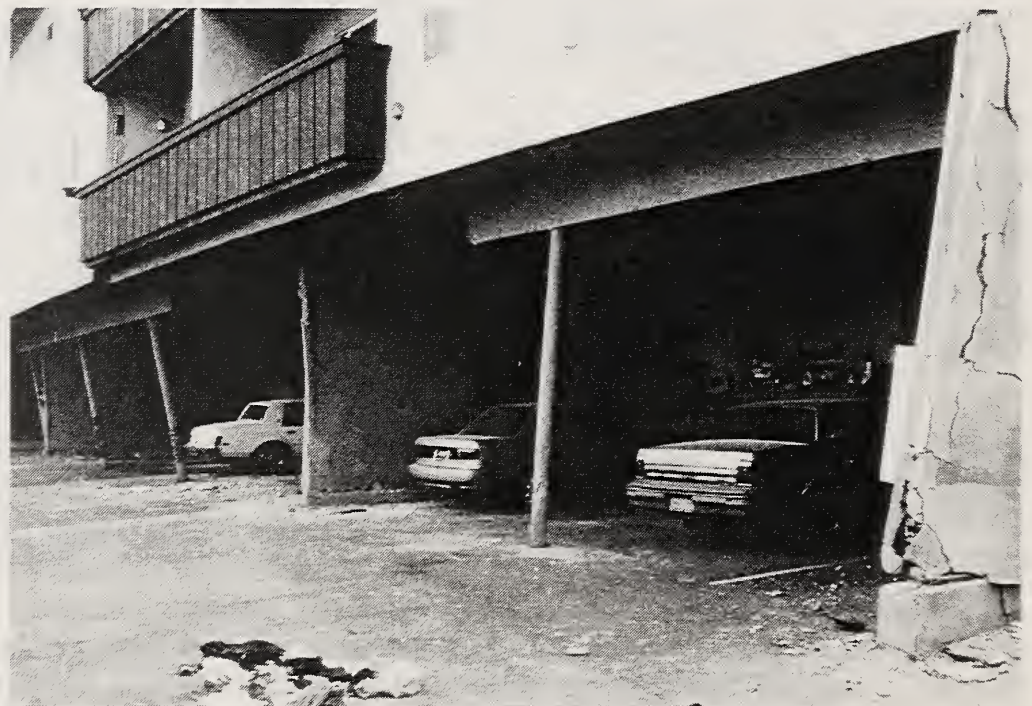
Figure 3.5 Steel pipe columns between parking bays supported the upper stories of the Northridge Meadows apartment buildings. Few of the buildings in the north half of the complex collapsed, but all were damaged.

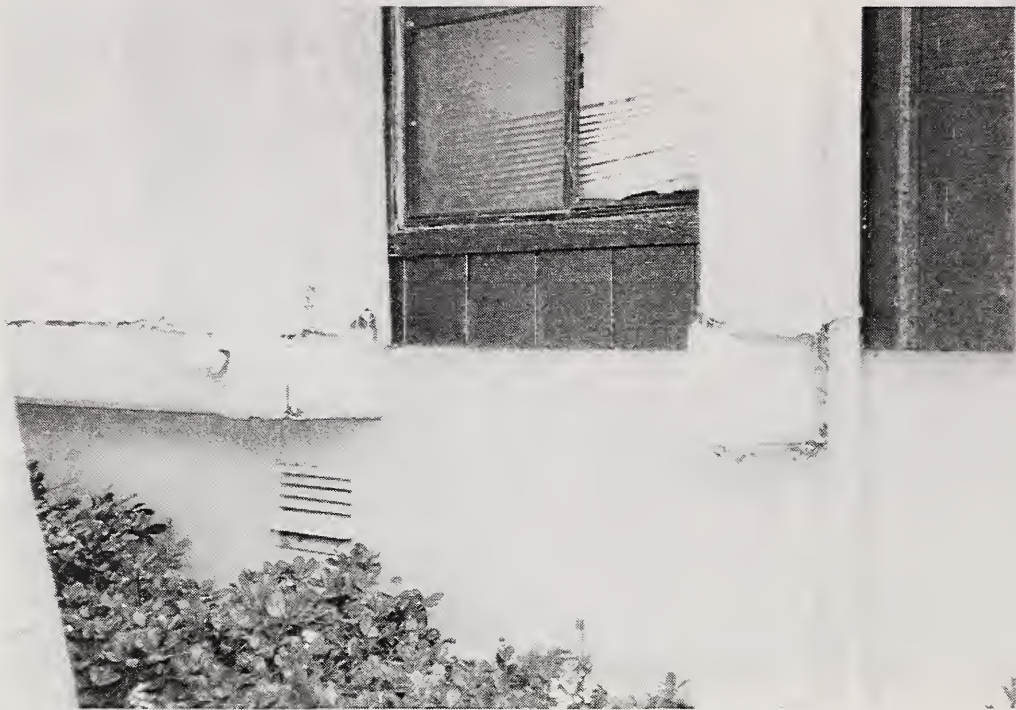
Figure 3.8 Horizontal cracks at the interface of the foundation wall (usually concrete) and the first story (typically wood-framed with stucco facade) were often seen in damaged low-rise apartment buildings.

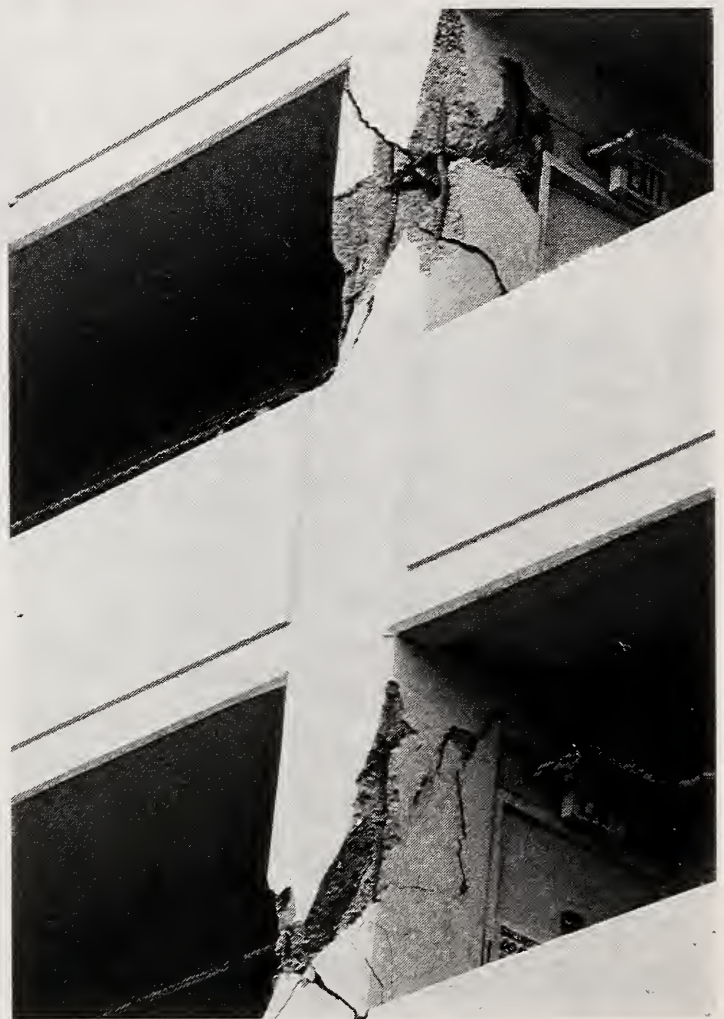
Figure 3.15 A closer view of the failed columns at the back of Champagne Towers shows minimal transverse reinforcement.

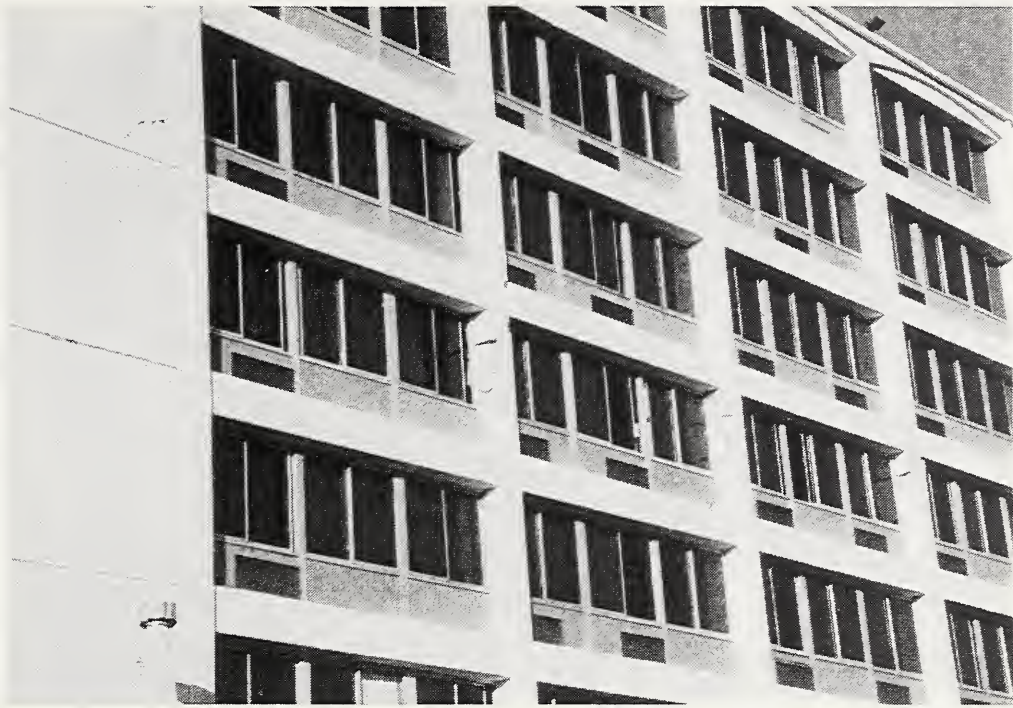
Figure 3.16 The bottom two stories of the concrete frame Holiday Inn in Van Nuys were damaged in the 1971 San Fernando quake and subsequently repaired. In the 1994 Northridge quake, damage was concentrated at the top of the fourth floor columns.

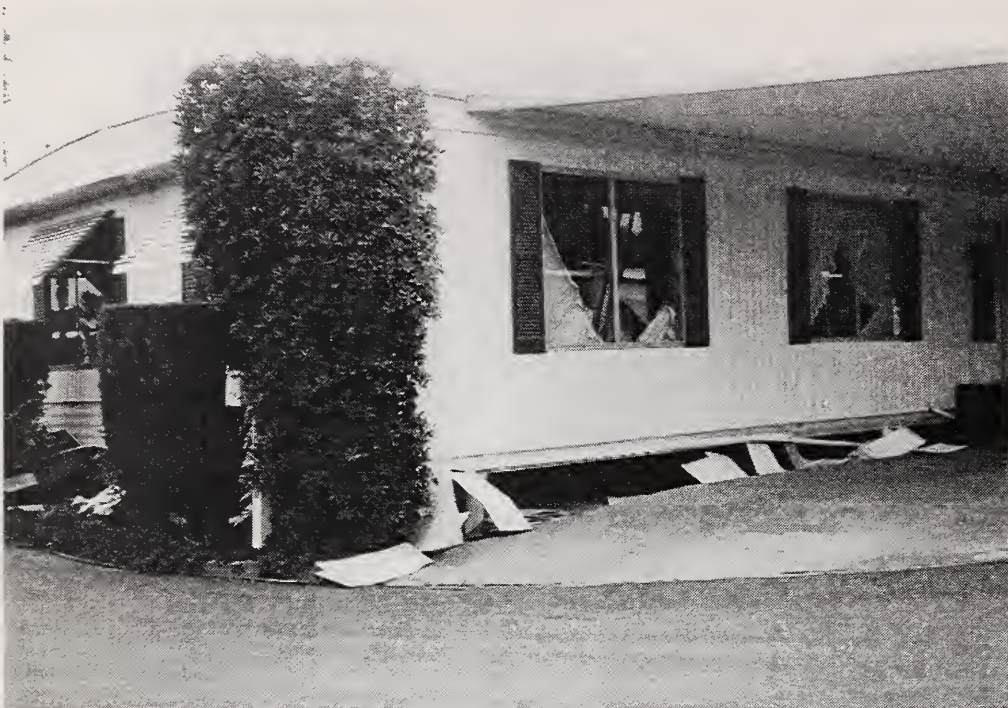
Figure 3.19
Damage to
manufactured
homes caused by
collapsed supports
was common.

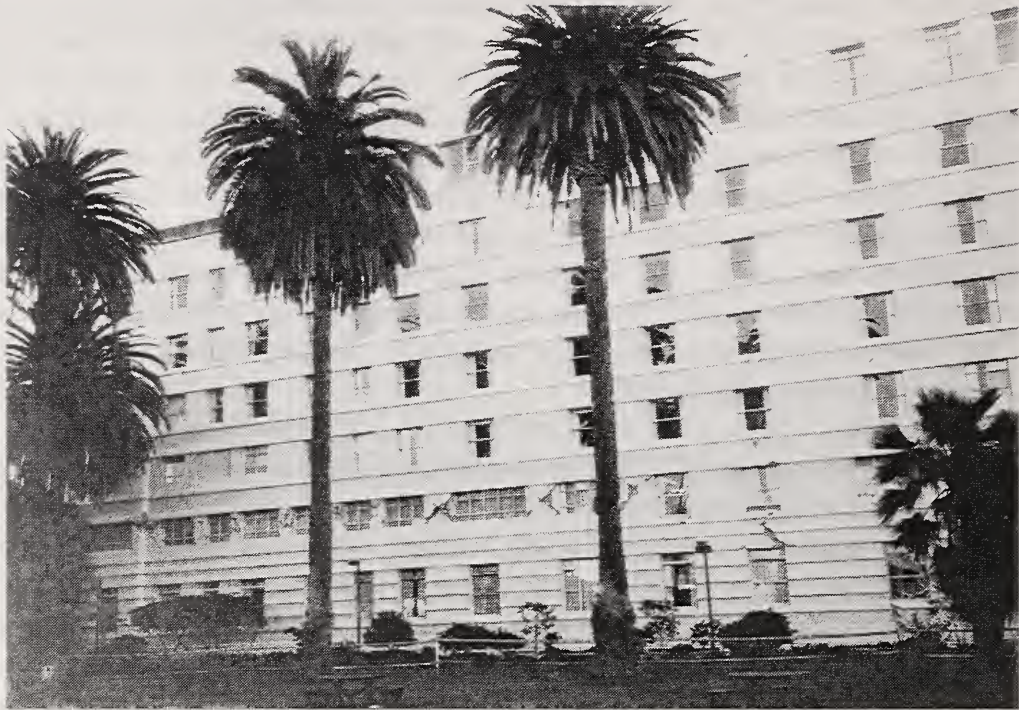
Figure 3.23 The seven-story northwest wing of St. John's hospital in Santa Monica experienced severe X-cracking in the piers between the second story windows.

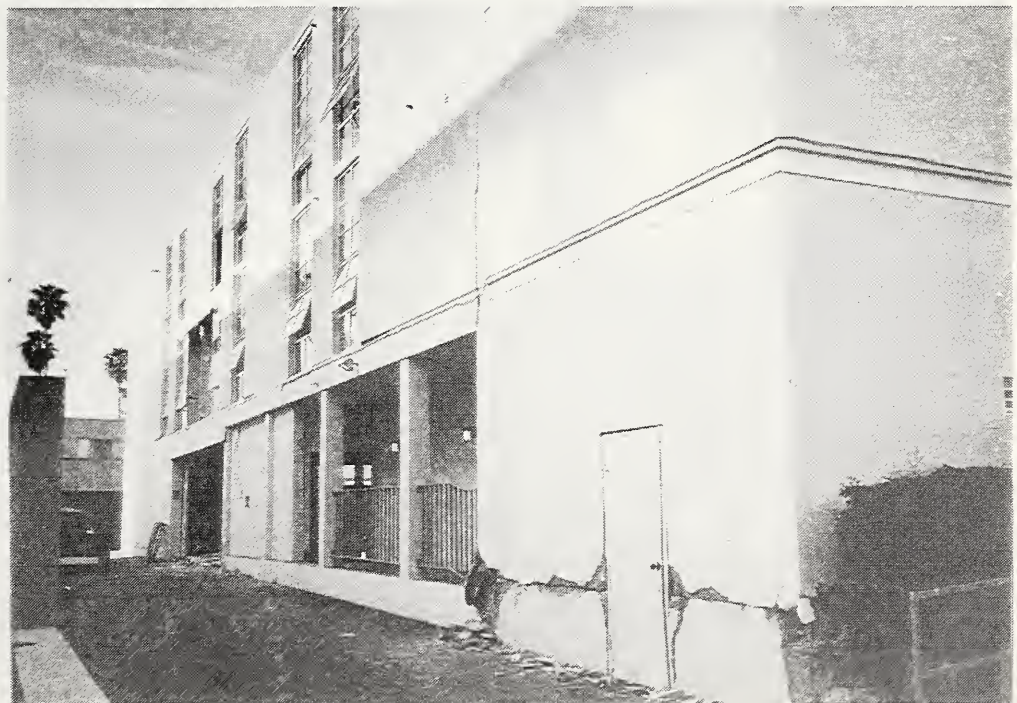
Figure 3.27 The facade of the five-story Berkley Convalescent Hospital directly adjacent to the St. John's Hospital complex consisted of two wythes of brick masonry with a reinforced and grouted space between. In some places, all three layers of this facade were destroyed along lines of diagonal cracking. The facility was evacuated.

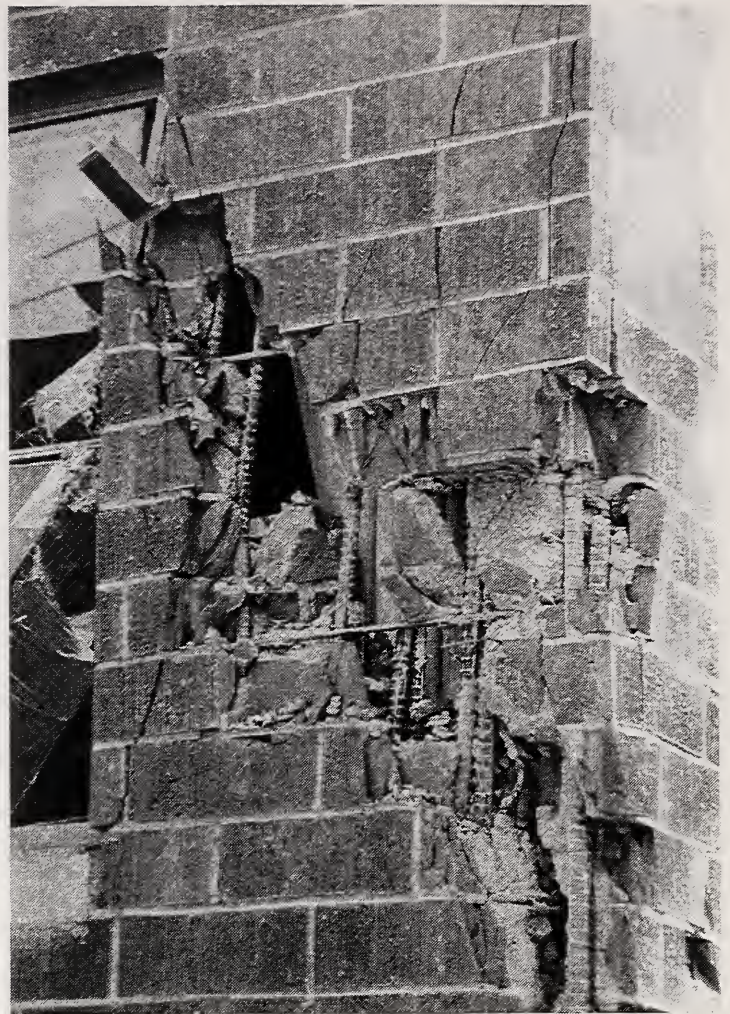
Figure 3.28 Two faces of the Berkley Convalescent Hospital had wing walls separating balconies. The ends of these wing walls spalled at the lower stories.

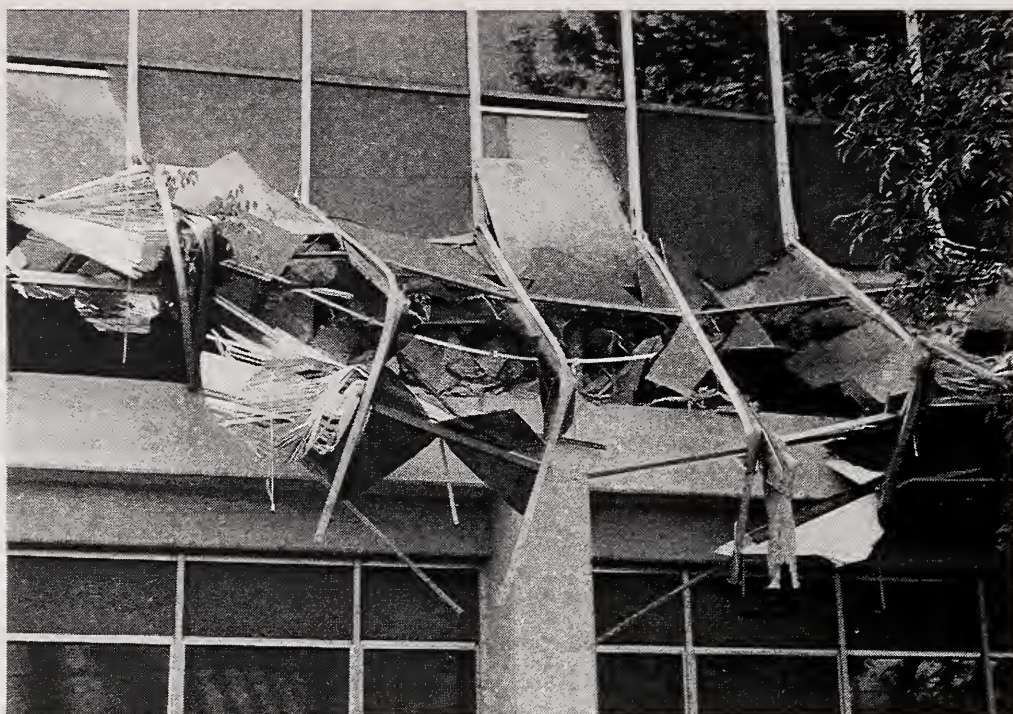
Figure 3.41 The second story of the concrete frame Kaiser Permanente office building on Balboa Avenue in Northridge completely collapsed. The first story was relatively undamaged, suggesting it was far stiffer than the story above.

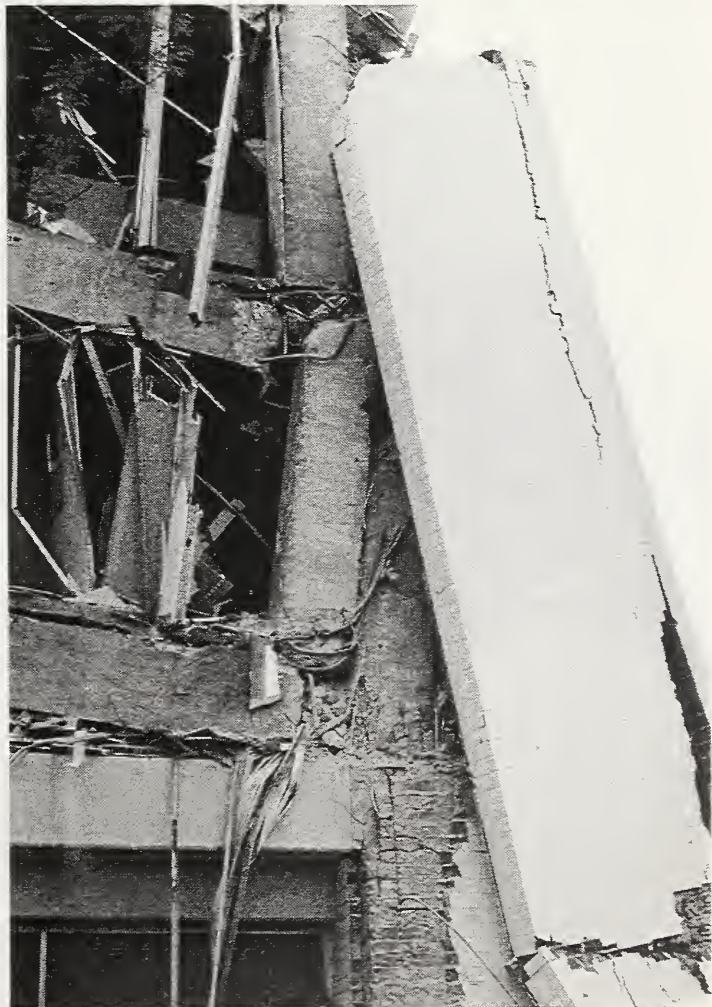
Figure 3.44 The exposed concrete
frame of the Kaiser Permanente
building, revealing deep beams,
suggests that the building had a strong-
beam, weak-column configuration.
Except for the second story columns,
the columns and beams remained intact
while the joints disintegrated.

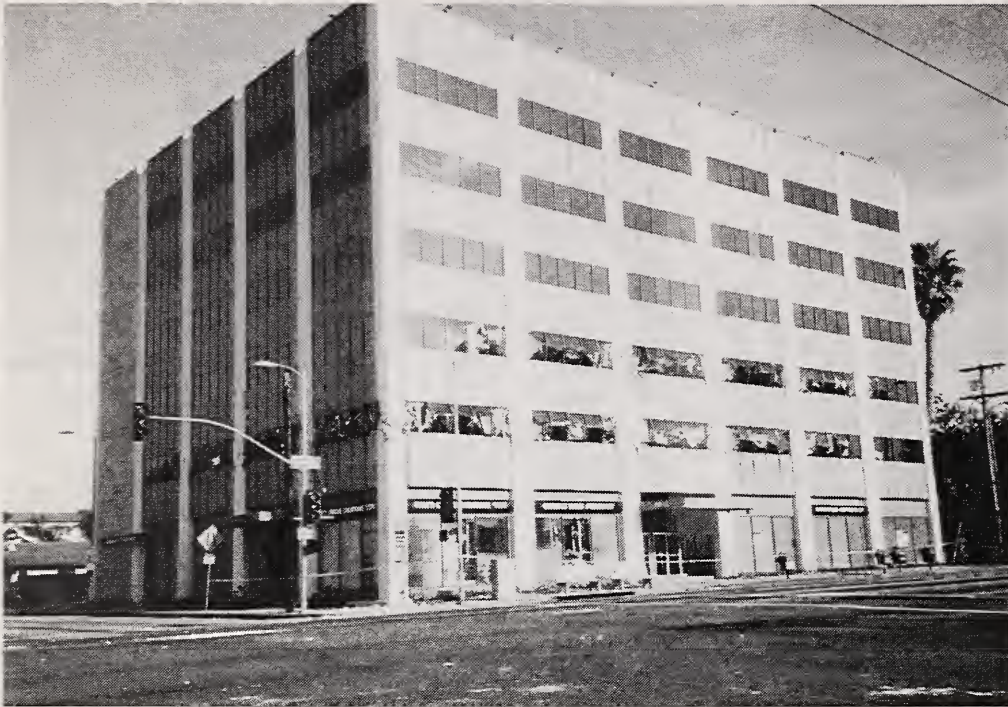
Figure 3.45 The six-story L-shaped concrete-frame Barrington Building on Olympic Boulevard in West Los Angeles lost its vertical-load carrying capacity at the second story.

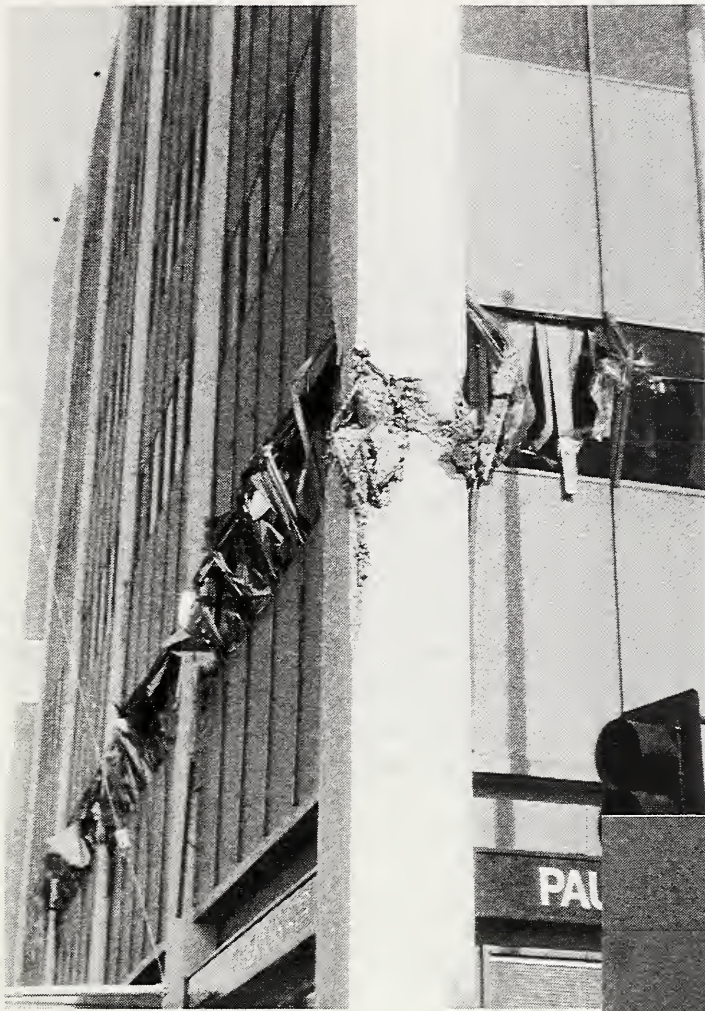
Figure 3.47 The cracking in the concrete columns at the second story was so extensive that the vertical-load carrying capacity of the building was affected. The building settled 50-100 mm at the second story, as these bulging window frames attest. The worst damage was at the southeast corner, the outside corner of the L-shape, pictured here. The building, which developed a slight list, was demolished within days of the quake.

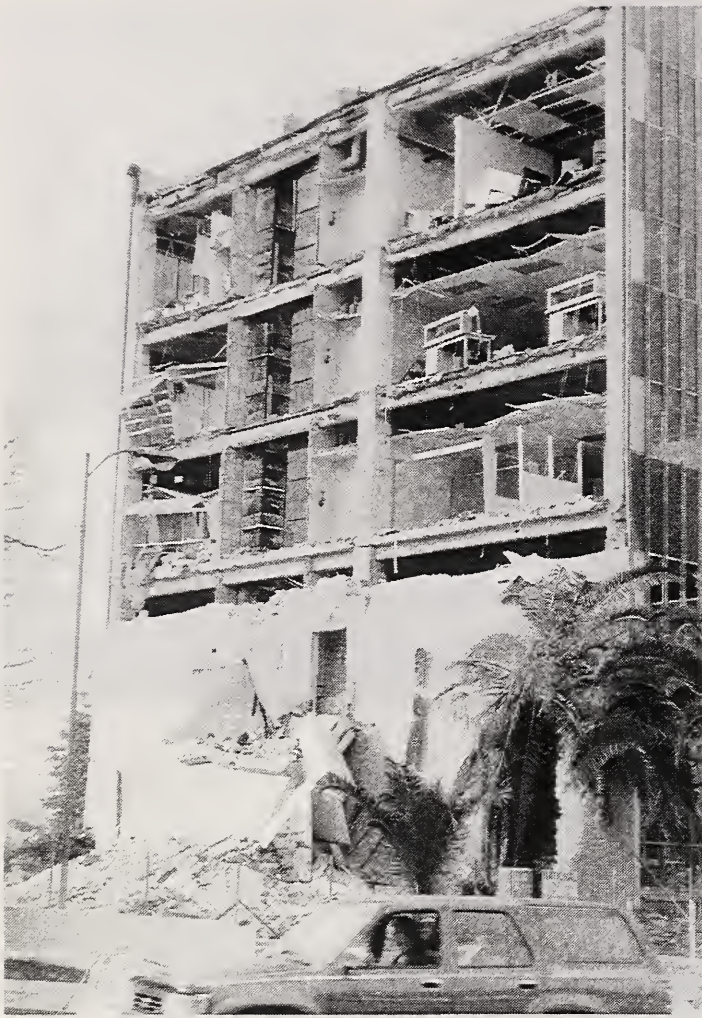
Figure 3.49 The east end wall and stair tower of a five-story apparently steel-framed office building on Sherman Way in Reseda collapsed. The enclosing masonry wall became detached from the structure and slid to the ground, with the upper stories remaining intact. The doorway opening in the wall, shown here resting at about the second story level, originally provided access from the top story to the stair tower.

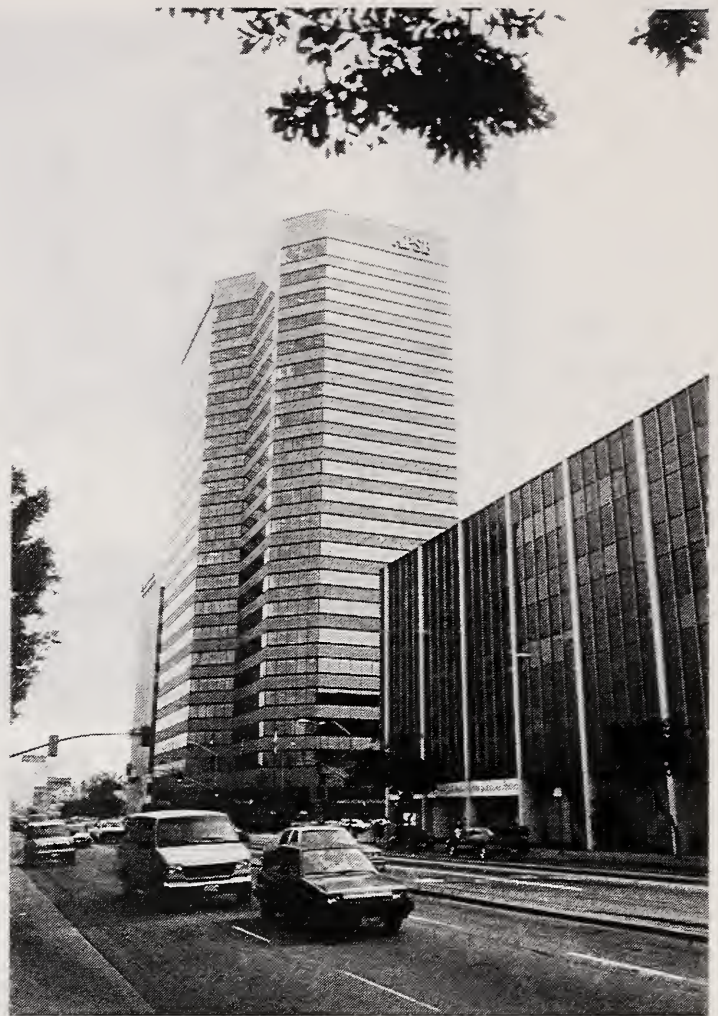
Figure 3.58 The reinforced masonry facade of this steel-framed building was badly damaged.

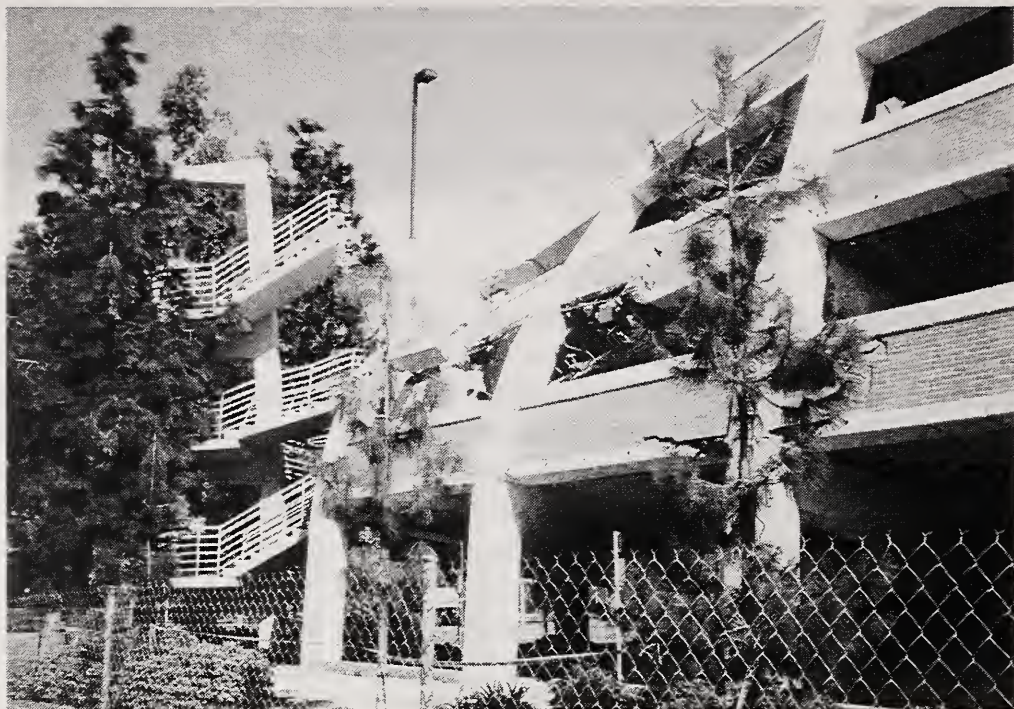
Figure 3.60 The three-year old four-level parking garage at the Northridge campus of California State University partially collapsed in the earthquake. The collapse apparently started at the interior, causing the exterior walls to be pulled in to the middle of the structure. Precast concrete "trees" were connected to form a moment-resisting frame at the exterior of the structure.

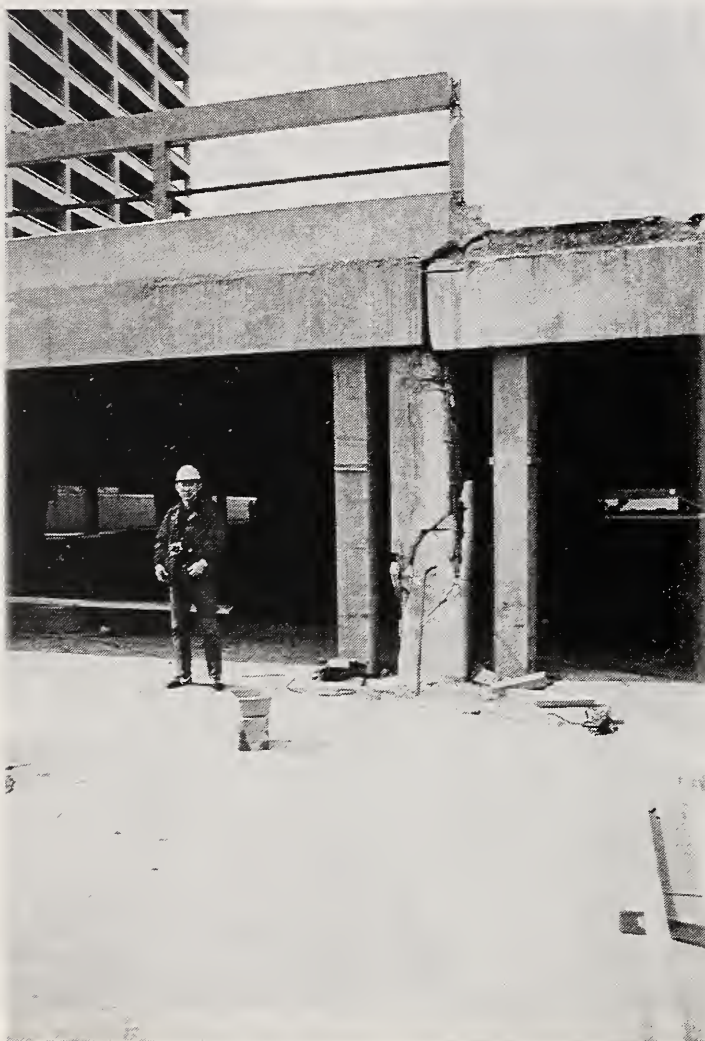
Figure 3.65 The exterior columns of the Trans World Bank parking garage, which had not been strengthened, were badly damaged.

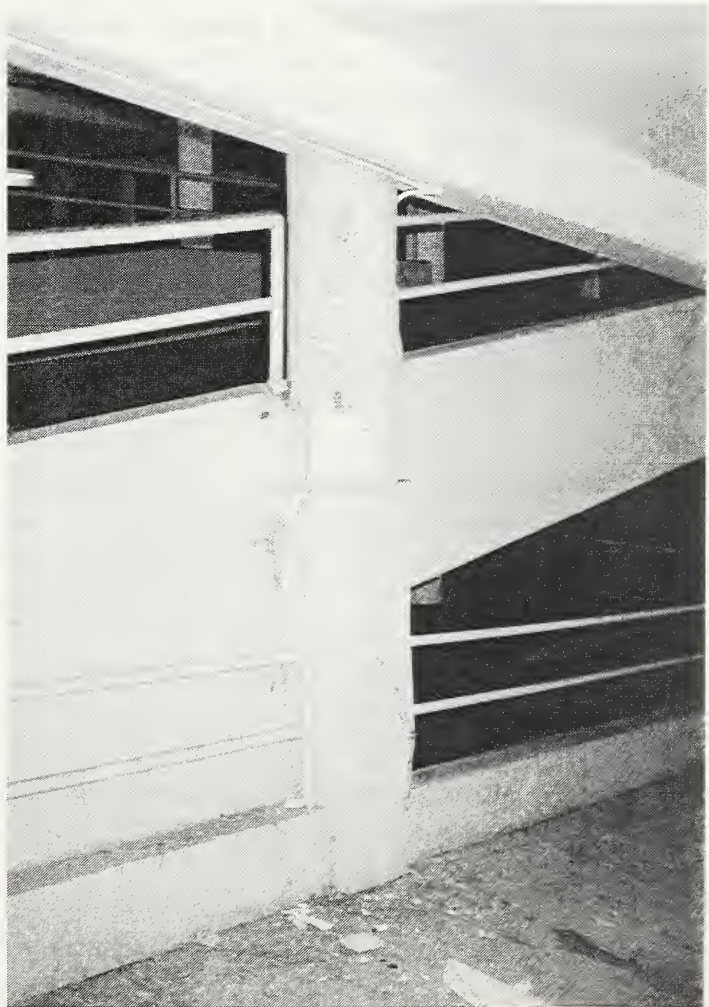
Figure 3.67 - In parking garages, ramps can cause unintentionally shortened columns, which are vulnerable to damage, as shown here.

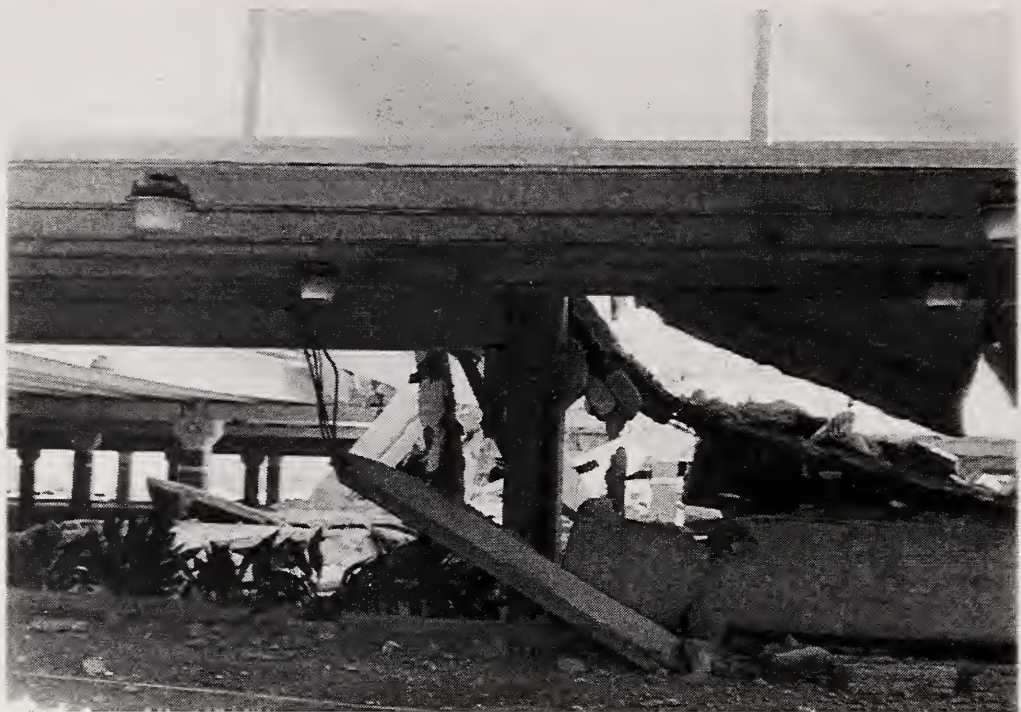
Figure 3.68 In precast parking garages, the support of the double-tees that comprise the floors is a vulnerable link in the system. This garage, at the north end of the Northridge Fashion Center, illustrates a common failure: the double-tees pulled off their supports, leaving the column-beam frame essentially intact.

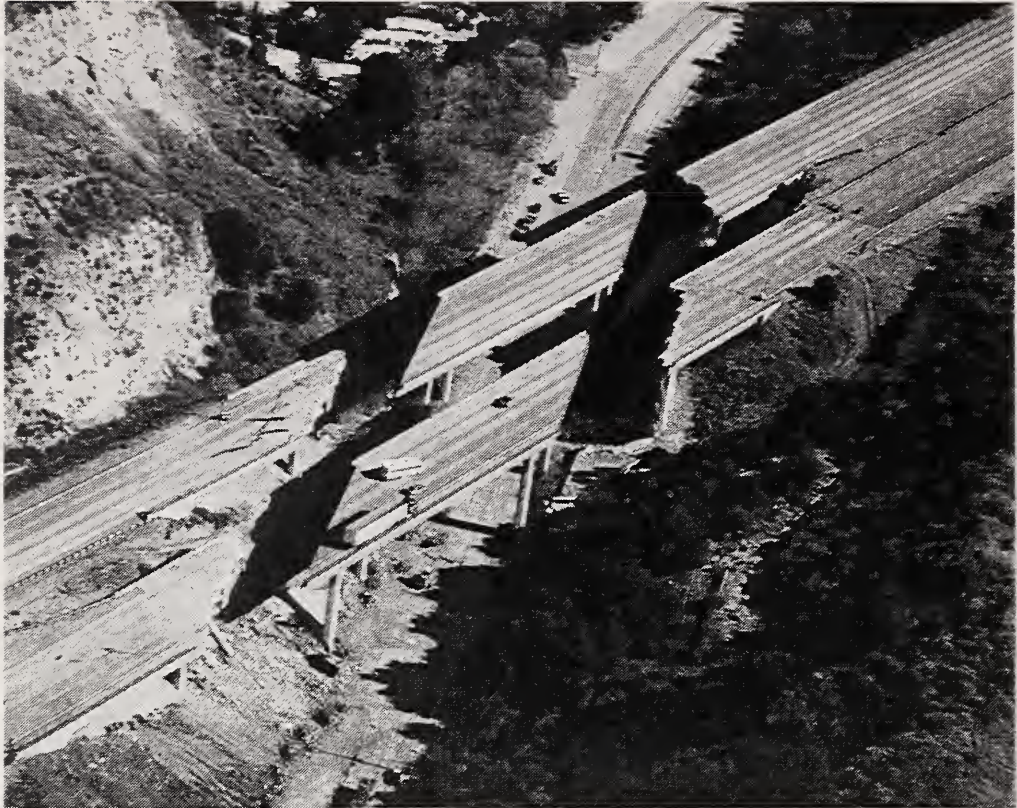
Figure 4.2: Aerial view of the bridge at Gavin Canyon, looking to the east, showing appearance of the four end spans shortly after demolition had begun

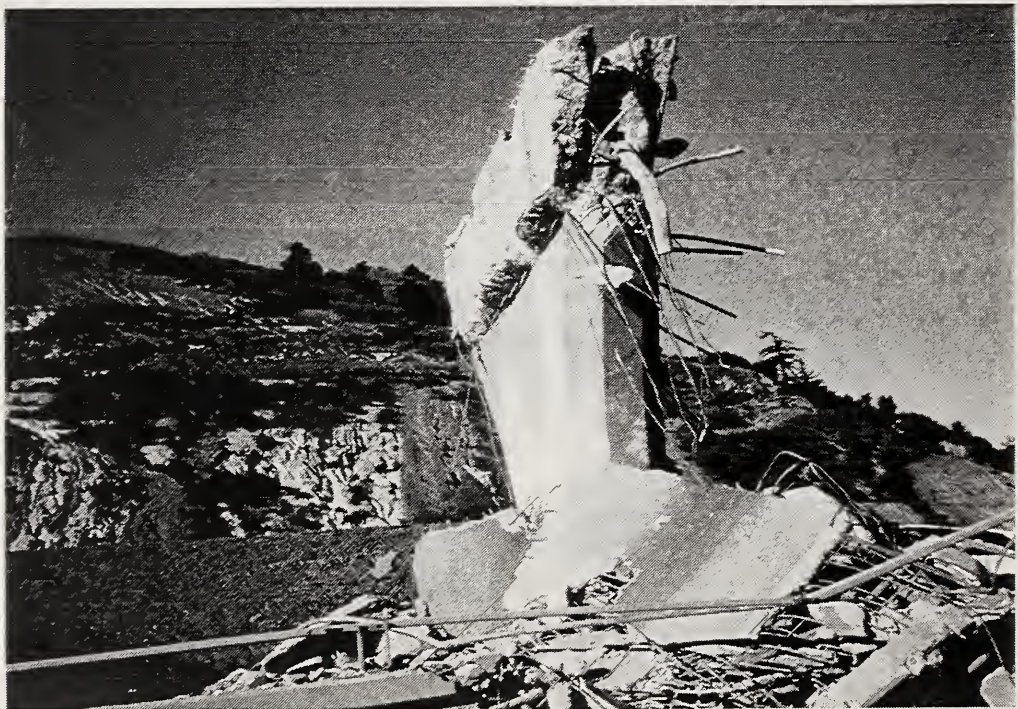
Figure 4.12 Damage at Pier 3 of the SR14/I5 Separation and Overhead, Ramp C, looking to the west (Courtesy of EERC)

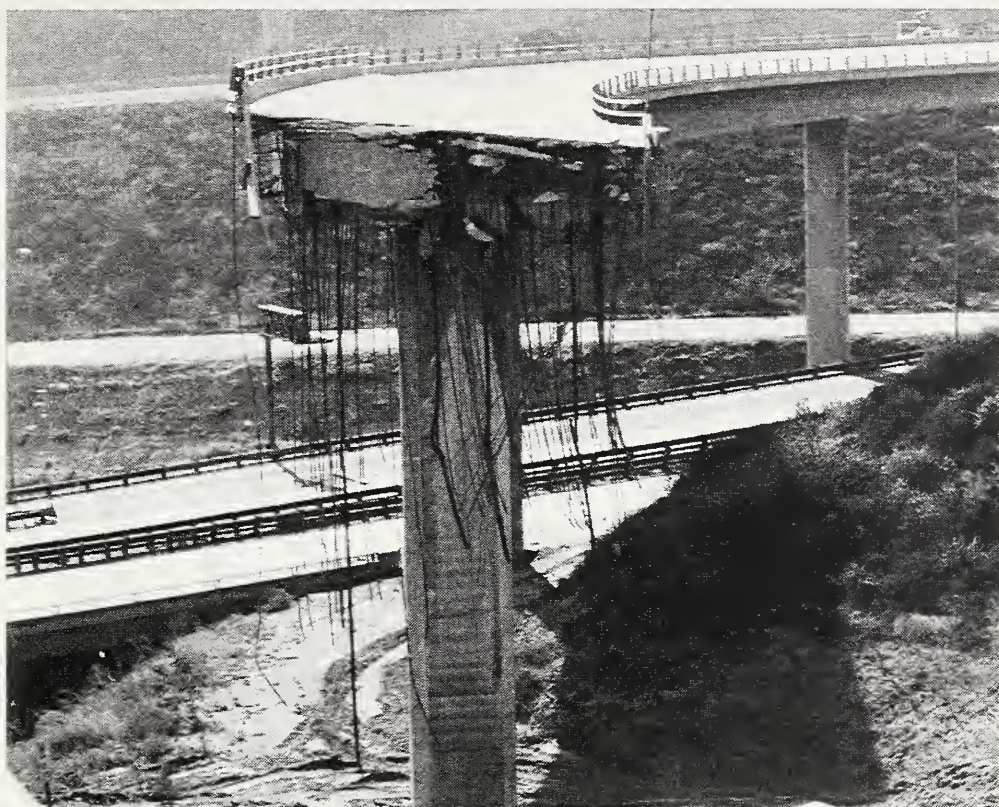
Figure 4.15 View of the flexural failure at Pier 3 of the SR14/I5 North Connector Overcrossing, looking to the south

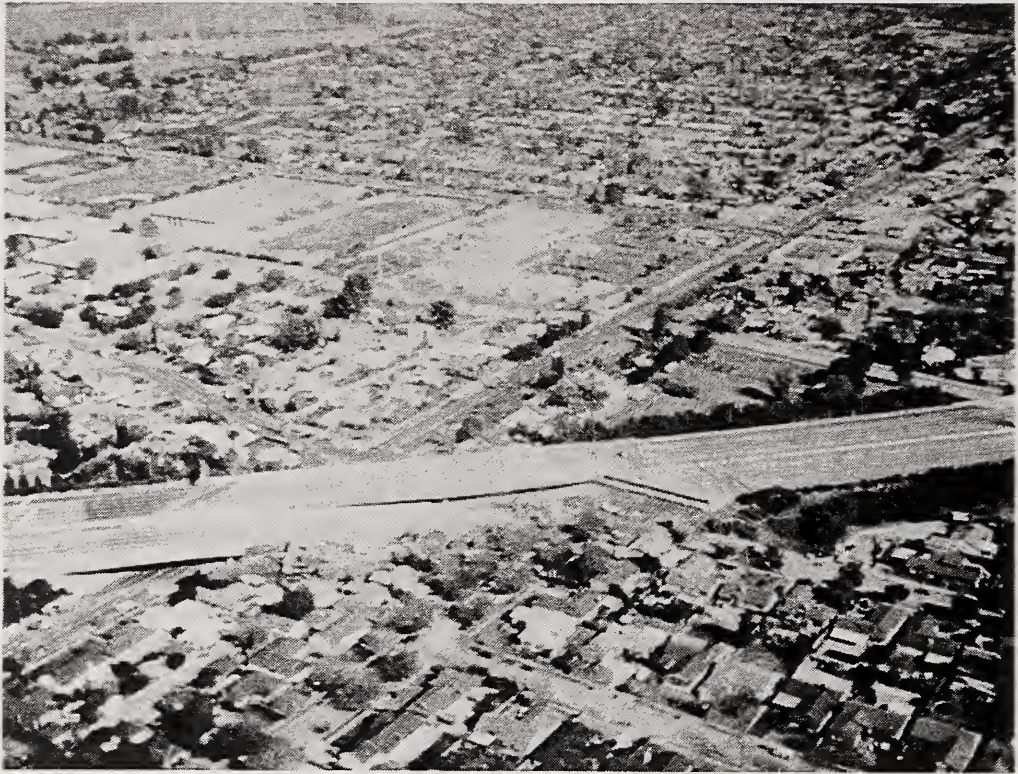
Figure 4.19 Aerial view of the SR118 Mission-Gothic Undercrossing, looking to the north showing collapsed eastbound bridge (Courtesy of FHWA)

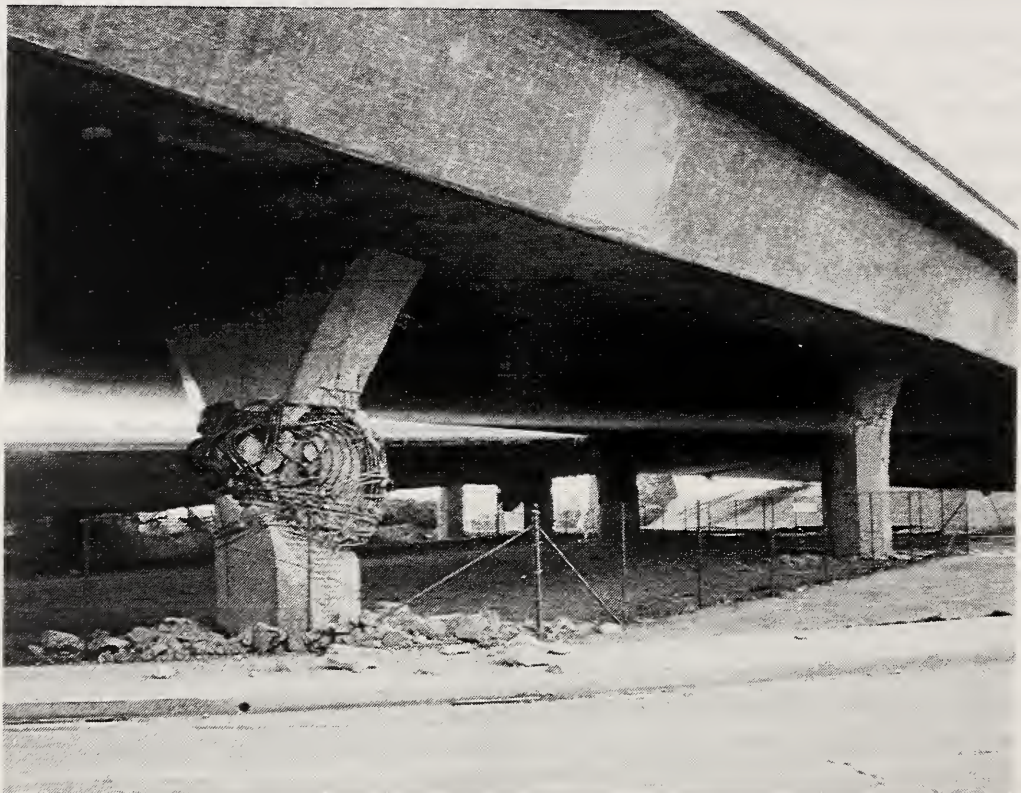
Figure 4.20 Damage to piers of the SR118 Mission-Gothic Undercrossing, looking to the northwest at the north face of the westbound bridge, Bents 3 (foreground) and 2.

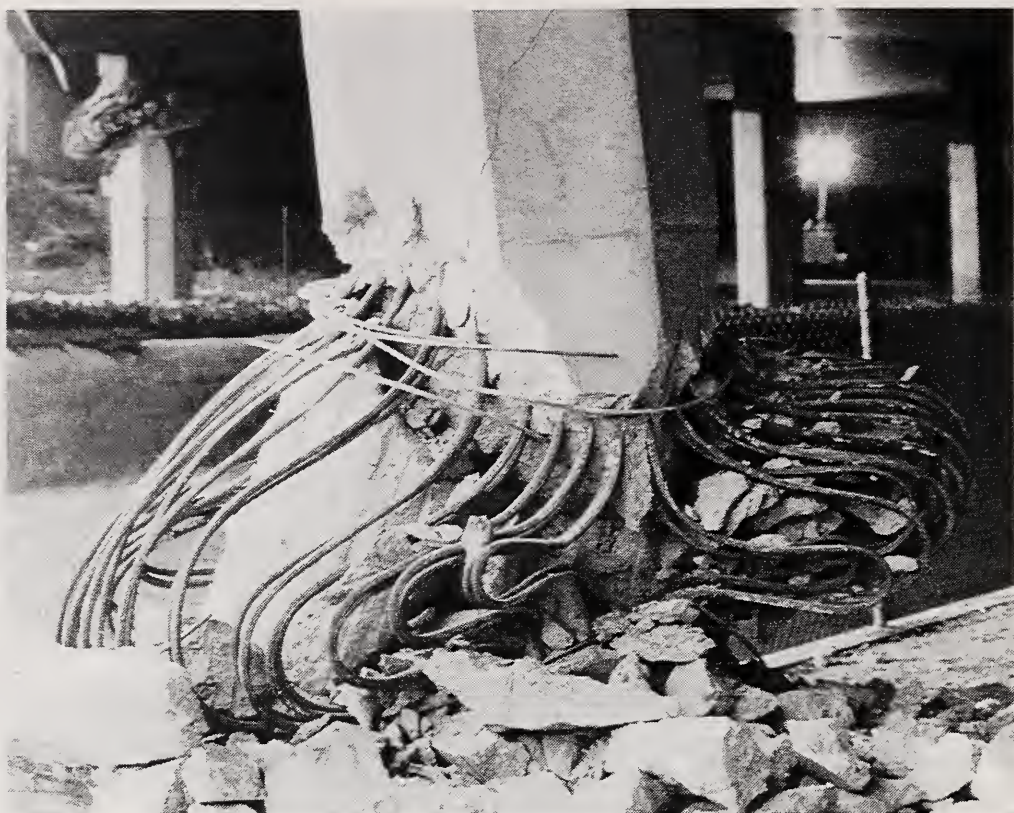
Figure 4.27 Damage to pier 3S-1 of State Route 118 at Bull Creek Canyon Channel, looking to the northwest

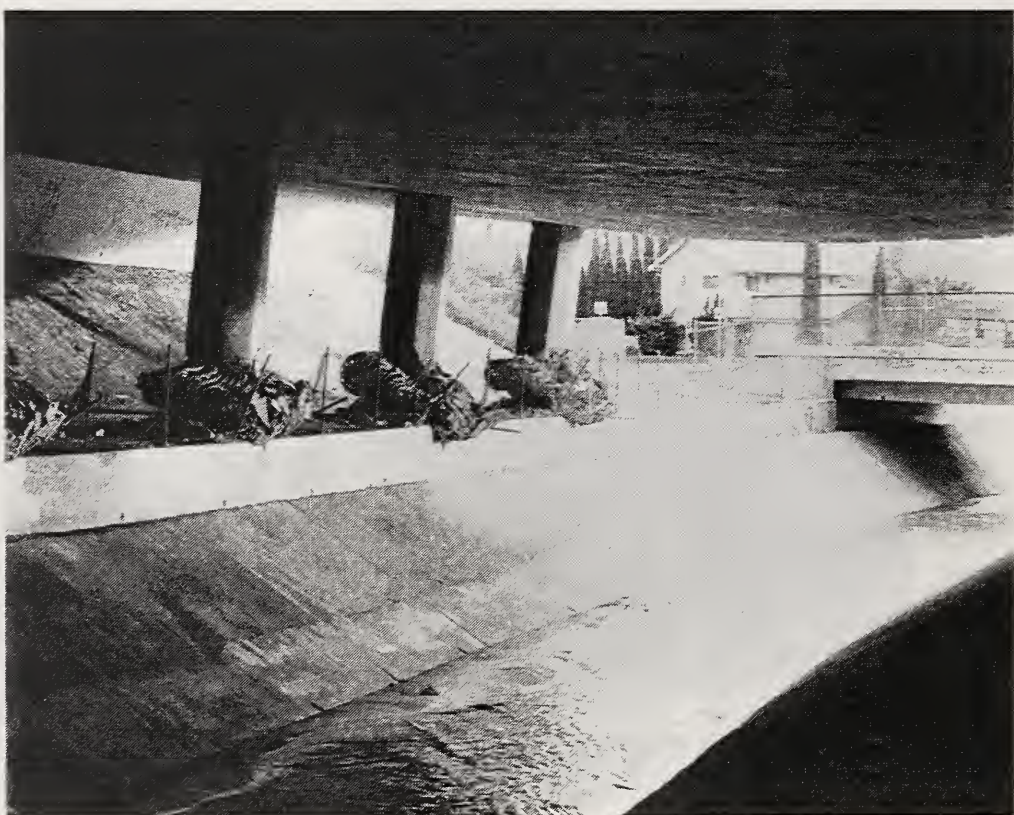
Figure 4.28 Damage to piers of Bent 3S of State Route 118 at Bull Creek Canyon Channel, looking to the southeast.

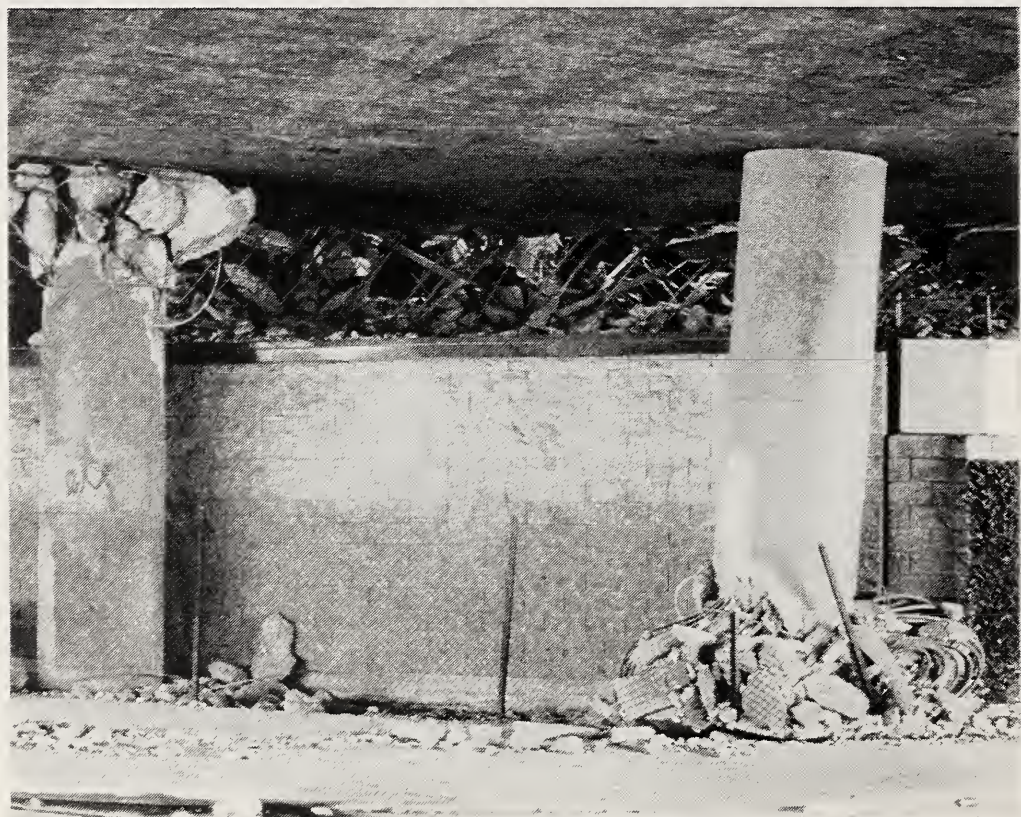
Figure 4.39 Failed piers in Bent 7 supporting westbound lane of I10 at Venice Blvd.

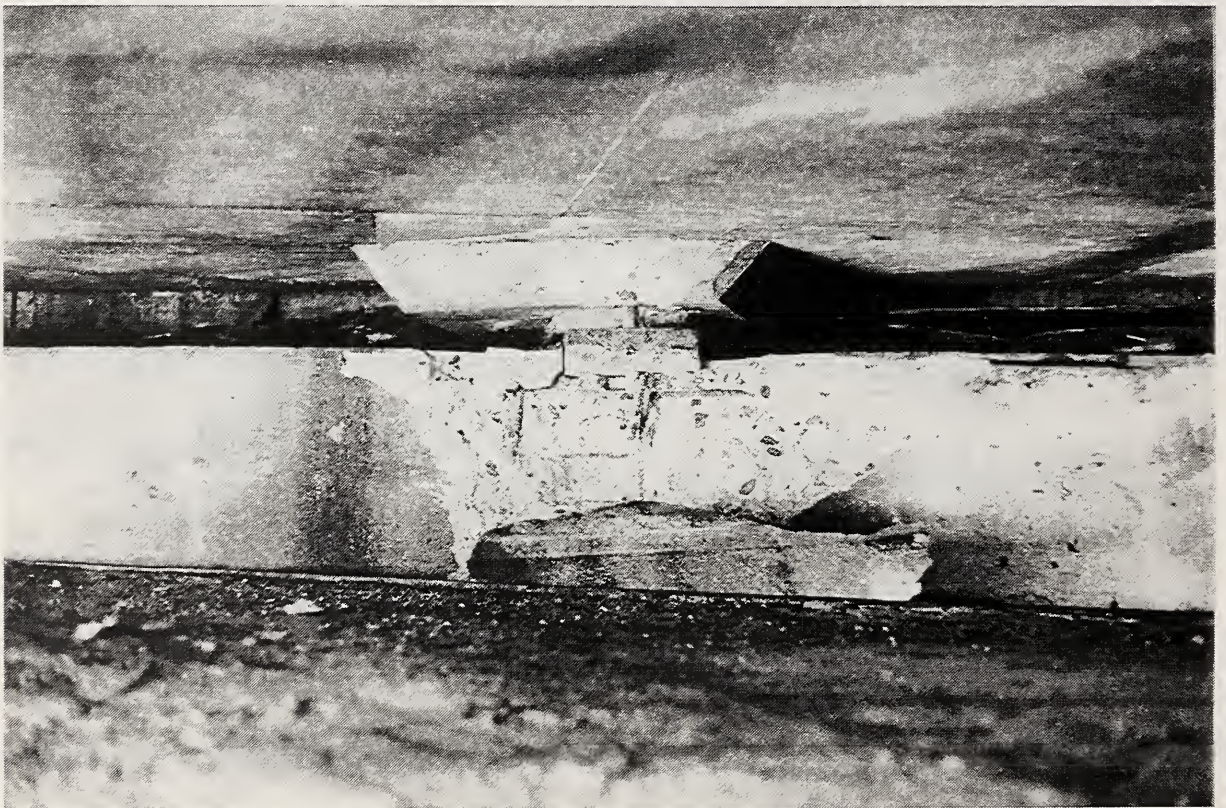
Figure 4.48 Abutment damage at sliding-type bearing
